**FIRST FIVE-YEAR REVIEW REPORT FOR
WPSC CAMP MARINA MGP SUPERFUND SITE
SHEBOYGAN, SHEBOYGAN COUNTY, WISCONSIN**

**U.S. Environmental Protection Agency
Region 5
Chicago, Illinois**

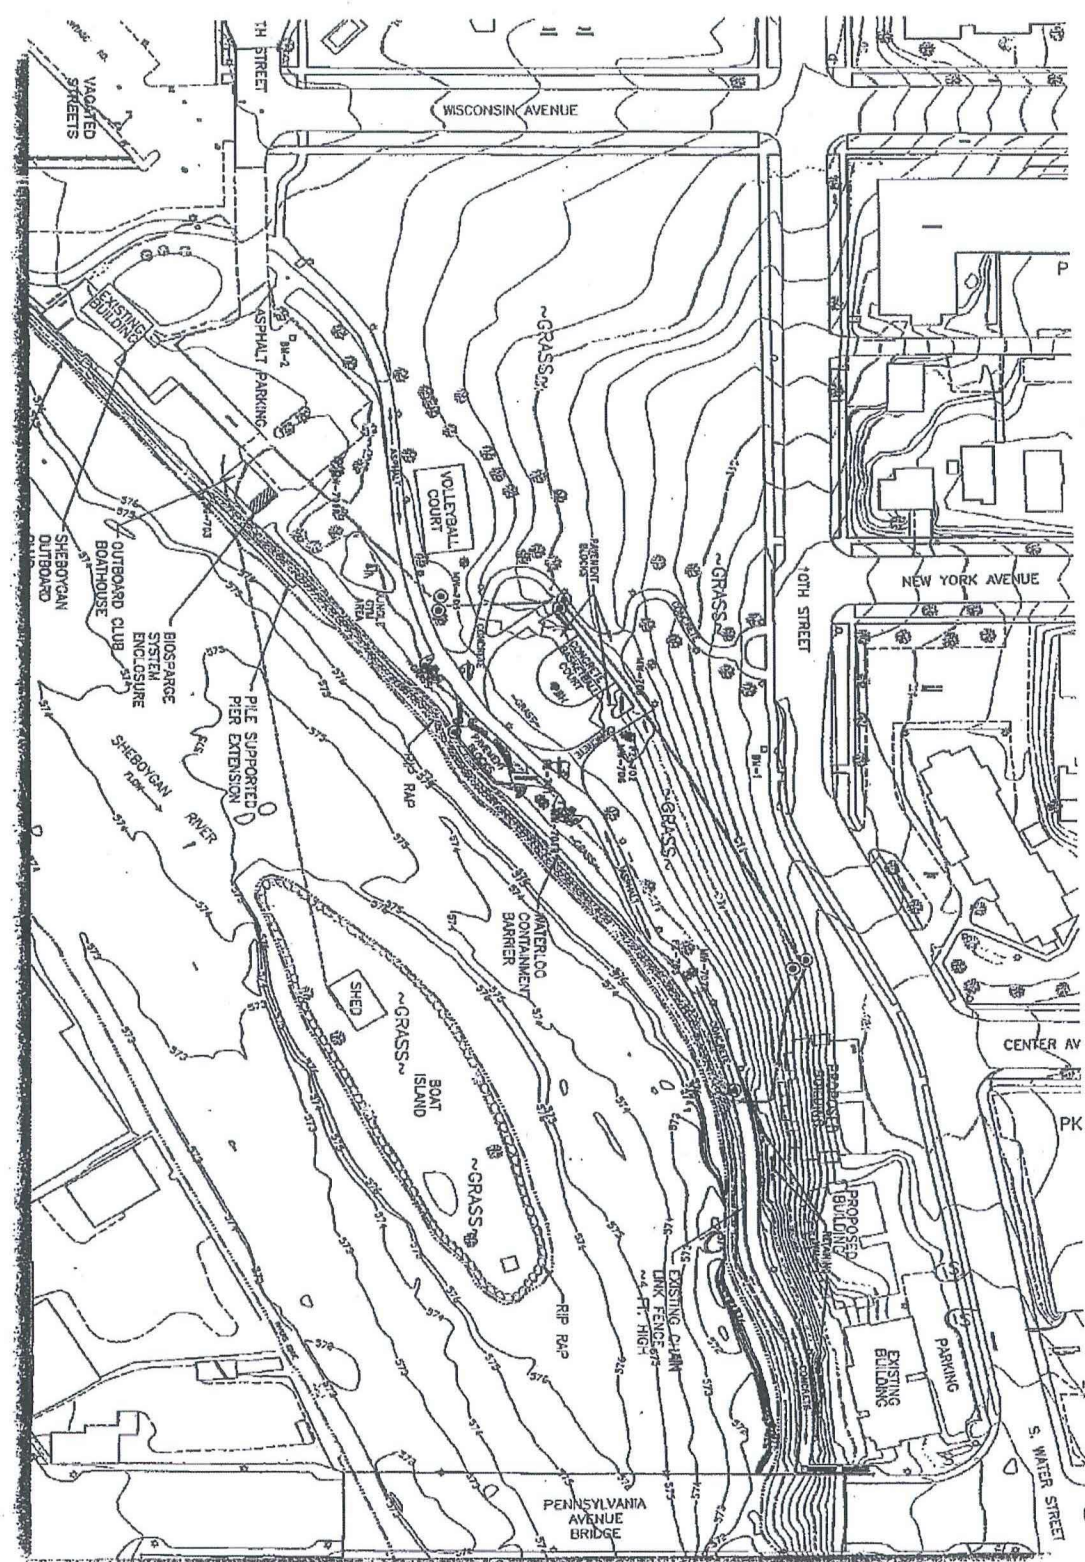
Figure 2 – Location of Waterloo Sheetpile Barrier and Geosynthetic Cover in OU1

As noted earlier, a subsurface containment system comprised of a Waterloo sheet pile barrier and geosynthetic cover was installed at OU1 along part of the shoreline (see Figure 2) as part of the state-mandated remediation activities. NAPL-impacted soils and sediments were present outside of and along the Waterloo barrier at depths up to 18 feet below the top of the sheet pile. The Waterloo barrier was not designed for the unbalanced earth pressures that the removal of these adjacent materials would cause. Consequently, a system of buttress piles and wales was designed and installed during the TCRA to provide temporary support for the Waterloo barrier as the adjacent NAPL-impacted materials were removed.

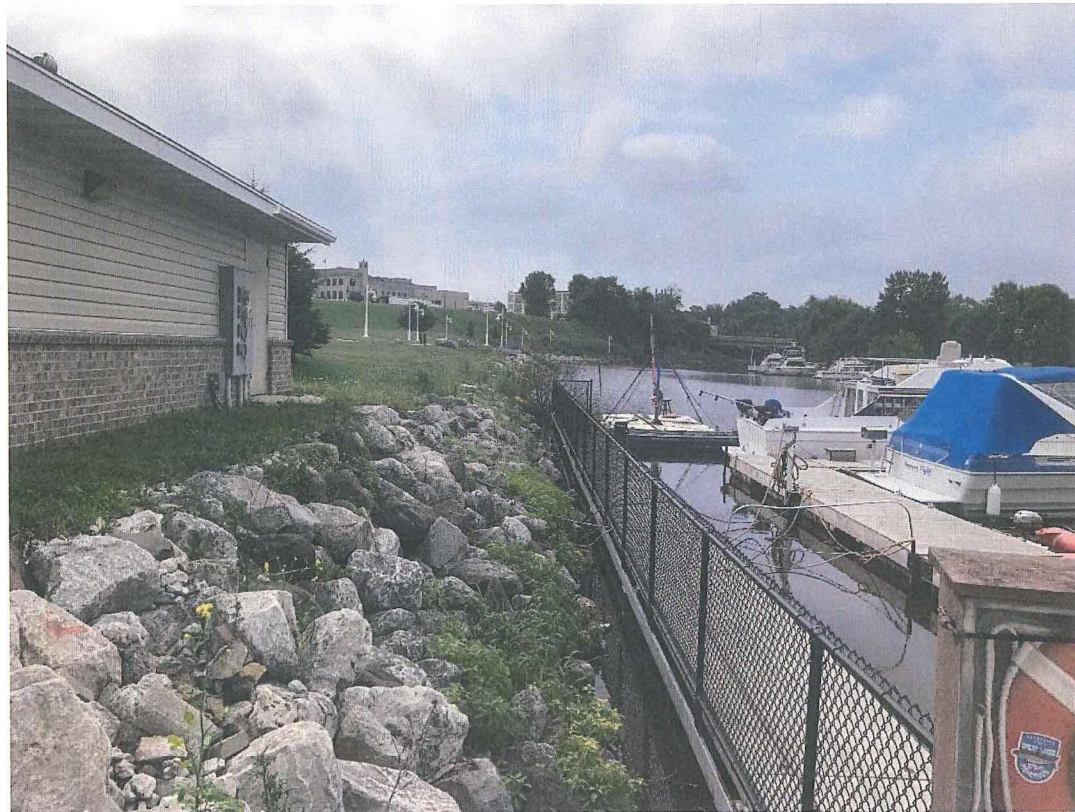
Picture 1 – Overview of WPSC Camp Marina MGP Site PAH Dredge Area

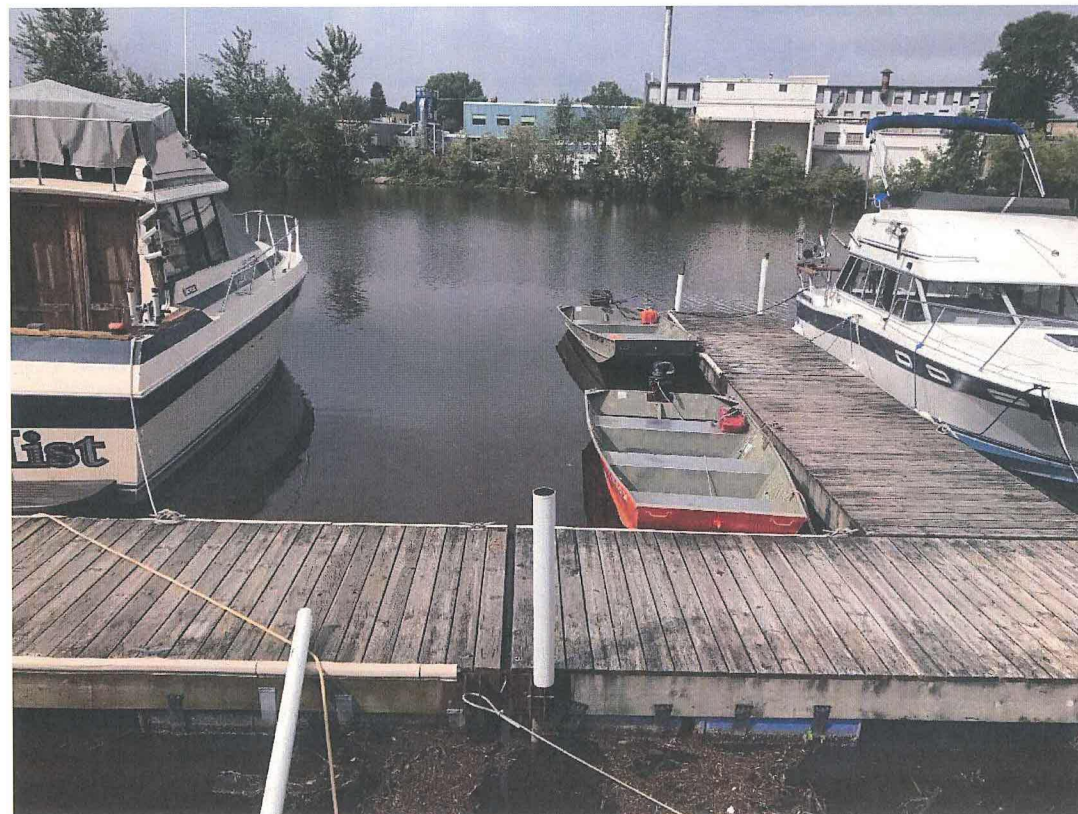
Picture 2 – WPSC Camp Marina MGP Site North PAH dredged area

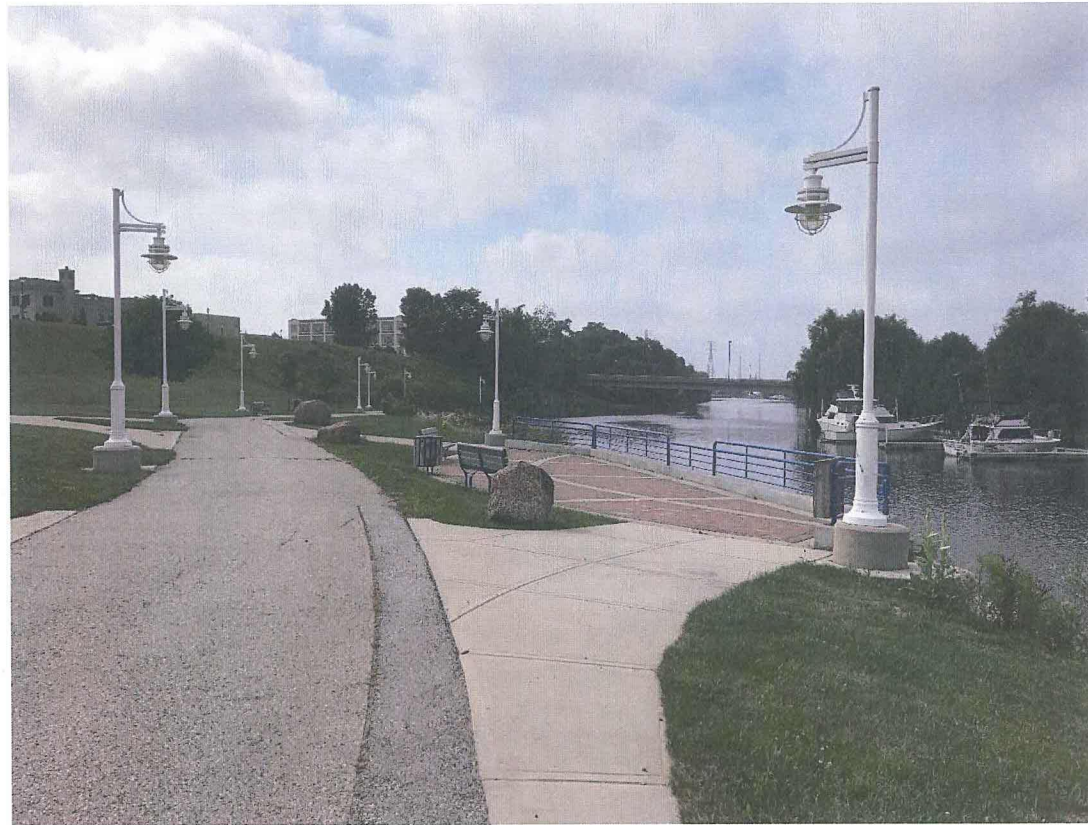
The inspection of the Site was conducted on 7/13/2017. In attendance were EPA Remedial Project Manager Pablo N. Valentin and Brian Bartoszek of Integrys, representative for WPSC. The purpose of the inspection was to assess the current Site conditions. The sediment areas were not visible during the Site inspection/walk through since they are located beneath several feet of water, but EPA confirmed that all OU2 areas have been restored and the city park is back to its intended use.

Picture 3 – WPSC Camp Marina Site Restored Park and dredged NAPL area

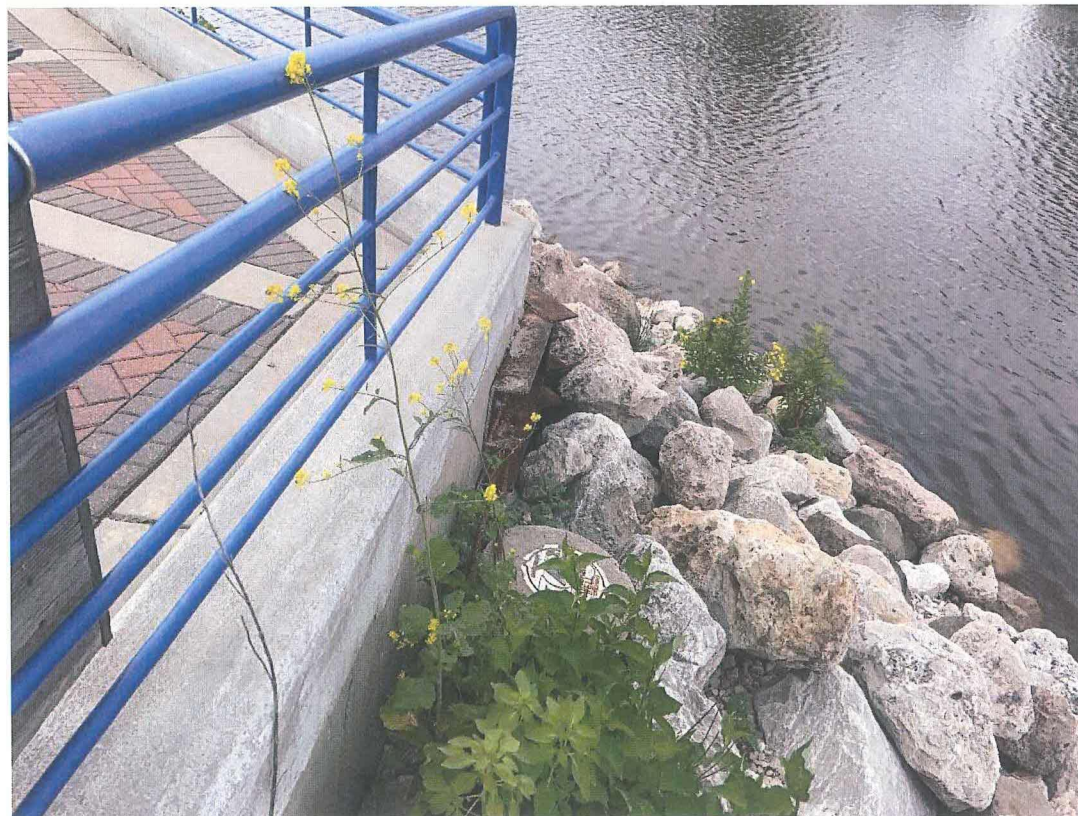
Picture 4 - WPSC Camp Marina MGP Site retaining wall and rip rap
